CASE STUDY FOR CURED IN PLACE LINING WORKS AT TEN FATHOMS DARTMOUTH

Location: Ten Fathoms, Dartmouth, UK
Client: Black & Veatch/ South West Water.
Date: May 2008
Contractor: Exjet Services.

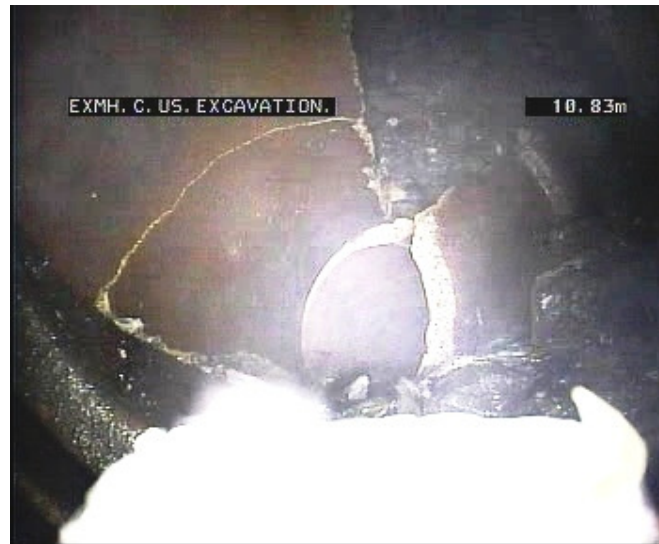
The survey revealed a number of defective pipelines, with the most prevalent below “Ten Fathoms”. This had shown that the existing 225mm Foul Water Vitrified Clay Pipe was in advanced state of degradation with significant levels of vertical deformation, loss of pipe wall material and subsequently loss of surrounding sub-strata.

Extent of damage to pipe prior to remedial works.

Utilising design equations that incorporate ground loading, ovality reduction factor, hydrostatic head of pressure and required long term flexural modulus as a minimum it was assimilated that a liner with an installed wall thickness of 14.5mm was required.

It was proposed that two separate liners should be installed; a 4.5mm liner acting as a support liner and a 10mm liner offering the required structural reinforcement. Utilising this method a declared value for full post cure of 550 N/mm² could be offered. This more than adequately covered the required structural strength.

In order to fill the external voids it was proposed that pressure grouting a reinforced acrylic grout through the wall of the liner should be employed. This method would consist of firstly installing a winch wire bond through the sewer to enable the towing of an inflatable packer through the sewer. Due to the severe vertical deformation that had occurred to the structure this was deemed necessary to prove that the packer could traverse the pipe and where the best points of contact for gel injection could be maintained.

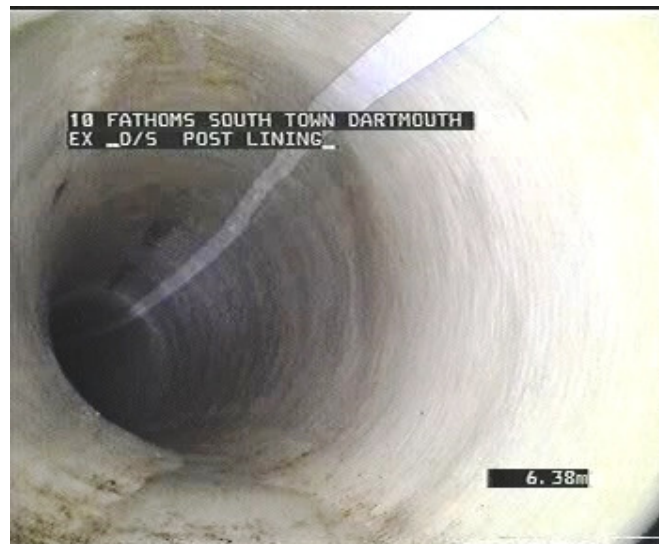
Completed Liner.

These works were subsequently approved and carried out successfully in May 2008.
