CASE STUDY FOR SEALING OF FAILED JOINT AT SOUTH TOWN OUTFALLS, DARTMOUTH.

Location: South Town Pump Station, Dartmouth.
Date: April 2008
Client: Black & Veatch/ South West Water.
Contractor: Exjet Services.

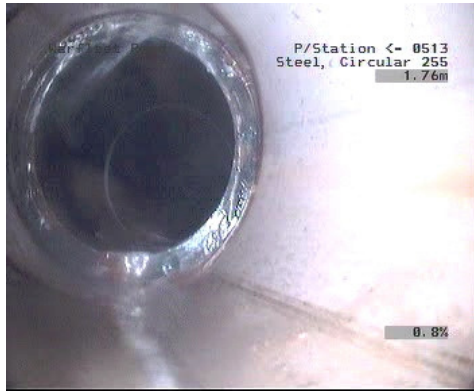
The survey clearly identified a failed joint at approximately 2.25M upstream of the pump station. This was subsequently identified as the joint between the stainless steel header from the pump station and the new PE Pipe.

Leak prior to sealing

The method of repair consists of encompassing the opposing joints either side of the defect with an inflatable packer and pumping an acrylic grout to a proscribed pressure into the void and subsequently through the defective joint and into the surrounding concrete.

Once some minor alterations to the inflatable packers had been made to allow for the differential in pipe diameters and the gel time set at 26 seconds the repair was initiated.

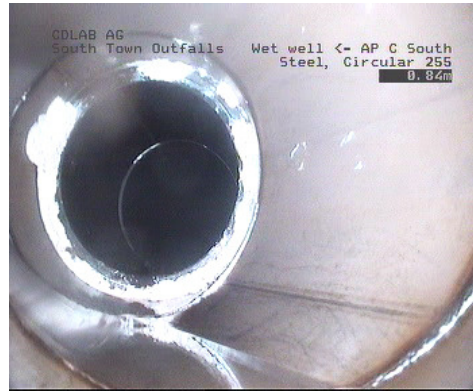
Completed Works

The repair was carried out on the 24th April 2008 and successfully passed a 2 Bar pressure test on the 27th April.
