# CLEARLINE PROFILER CASE STUDY DEFORMATION

**Location:** St Michaels Ave, Auckland

**Pipe Type:** Pre-cast Concrete (Stormwater)

**Date:** 22 December 2003

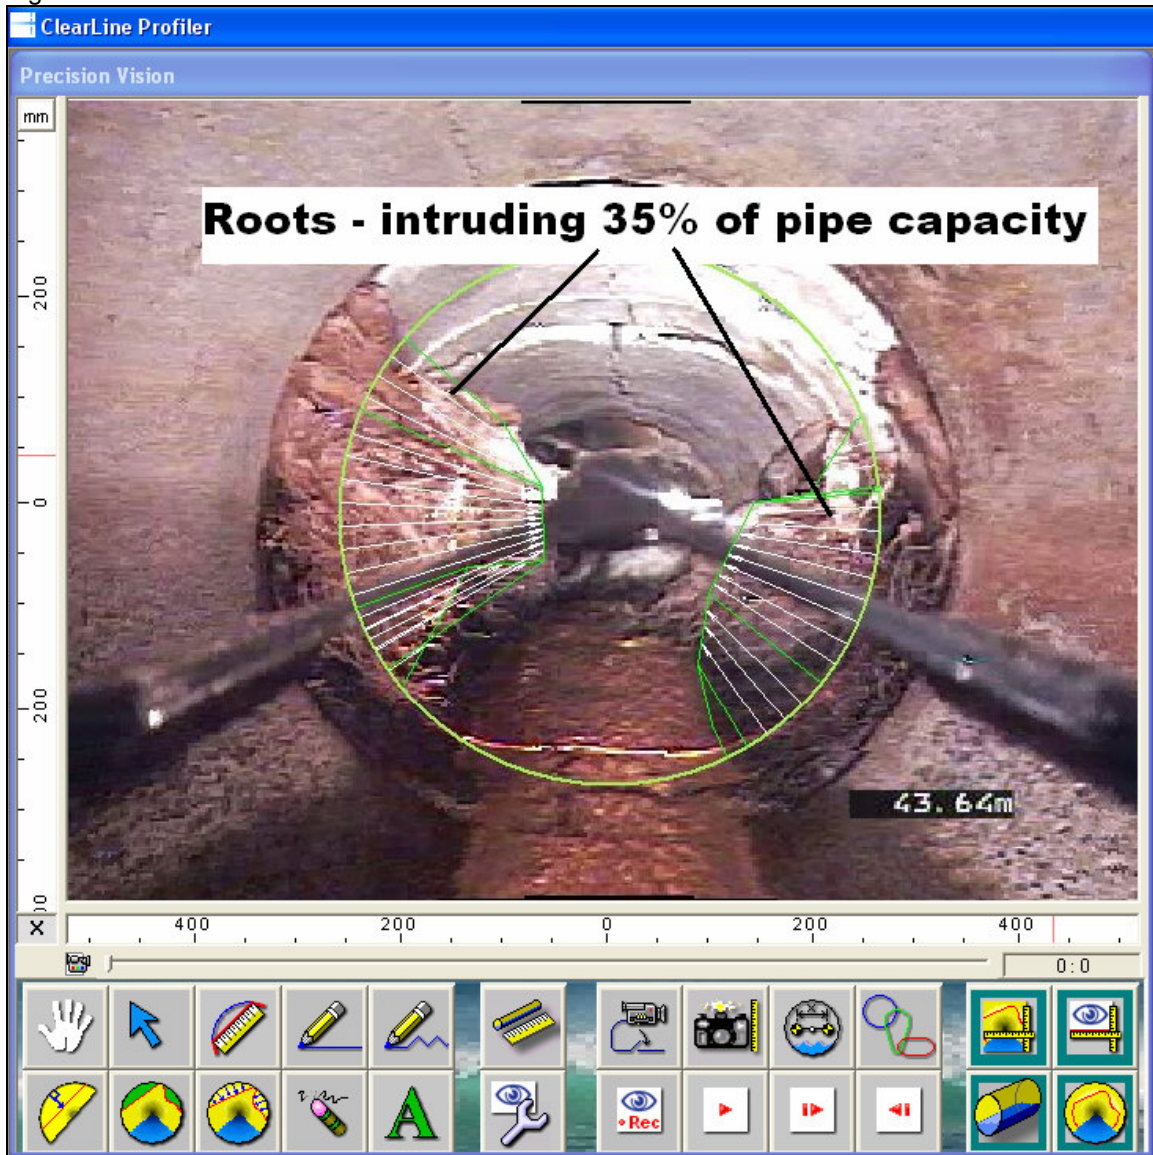
The camera and profiler were obstructed from further inspection 43m from manhole NV4675 as serious roots were intruding into the pipe. Fig1 shows the roots obstructing what appears to be

35% of the pipe cross-section. It was decided to profile from this point back to the entry manhole NV4676

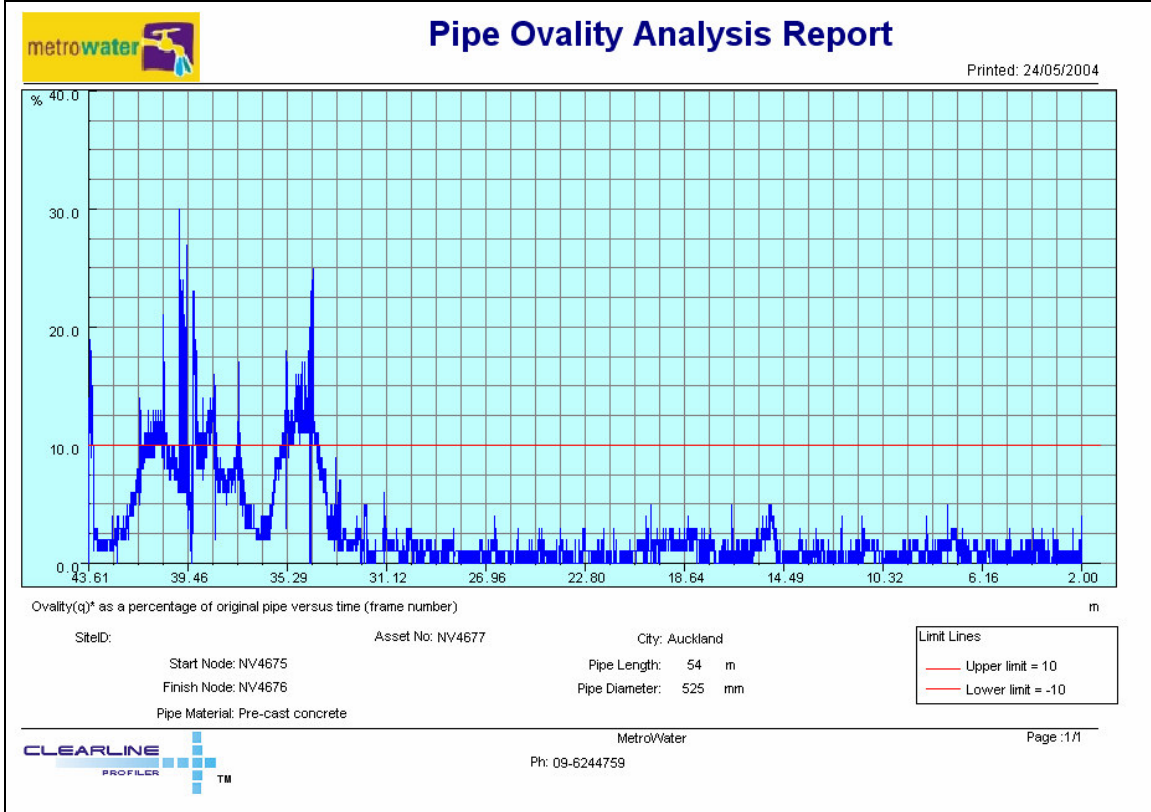
Fig2

Severe deformation can be seen from 33m to 42m in the Pipe Ovality Analysis Graph in fig2. Whilst the ovality varies in this section, the deformation can clearly be seen to exceed 10% at times. The mean pipe ovality reduces to less than 2% from 33m to the entry manhole.

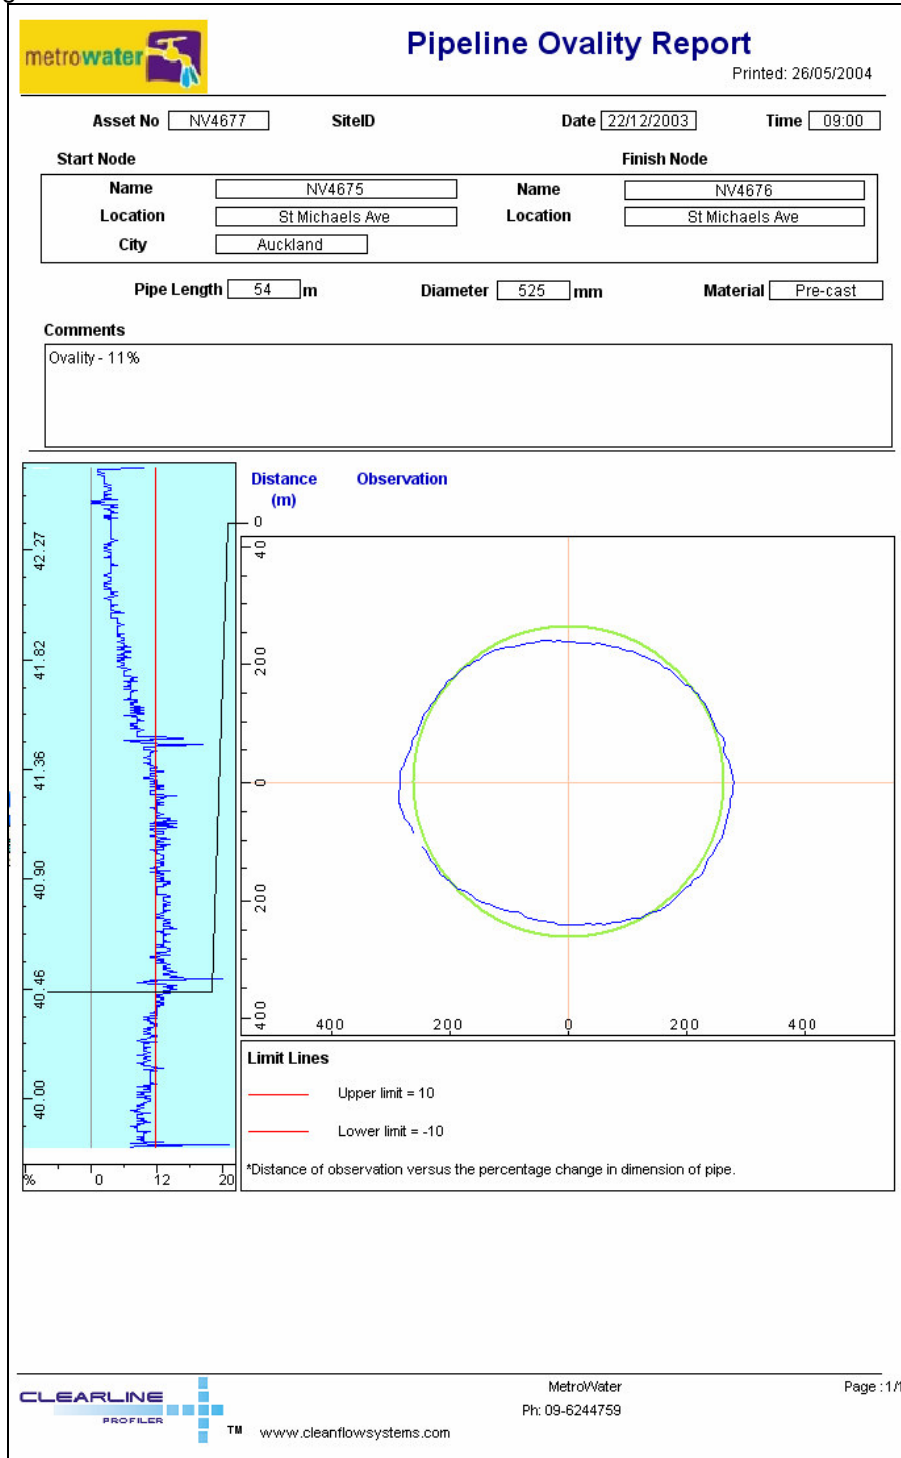
Fig3 shows the a cross-sectional digital profile 40m from NV4676. The ovality graph to the left was used to locate this particularly deformed section of pipe. The green ring represents the expected internal pipe diameter whilst the blue oval shape is the digital profile of the pipe derived from the laser image. Ovality is 11% at this point.

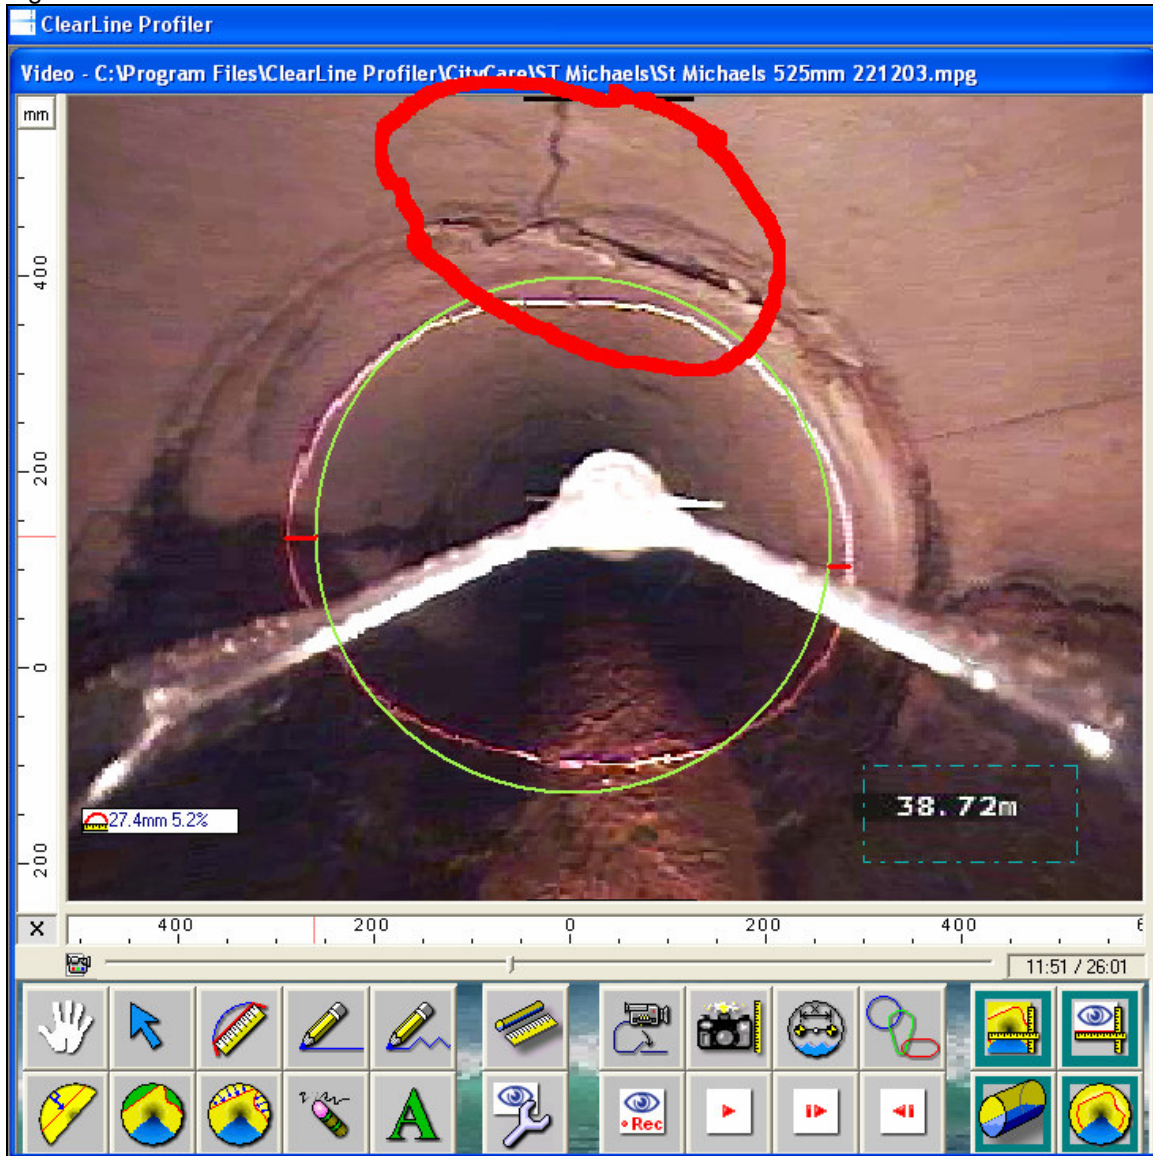
Fig4

The following (fig4) is a view of the same section of pipe, as seen during the pre-profiling (lights on). The expected internal pipe diameter is once again the green ring whilst the red ring is the actual pipe shape. Note the longitudinal and circumferential cracking in the invert.

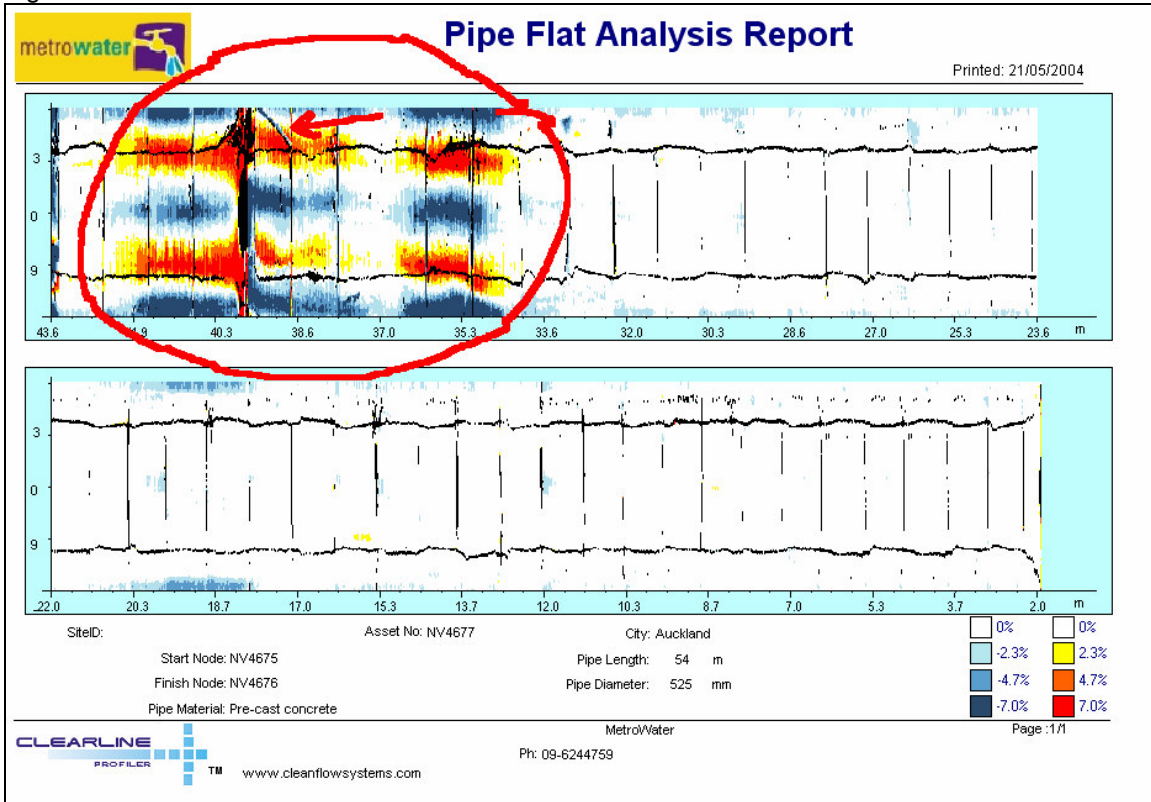
Fig5

The 'flat graph' in fig5 shows a topographical view of pipe radius when flattened. Once again the deformation between 42m and 33m is clearly seen, whilst minimal deformation is evident throughout the remainder of the pipe. In this case the red colouring shows an increase in pipe radius of 7.0% (39.3mm) while the blue is the equivalent radius decrease. The black vertical lines show the joints of the concrete pipe.

There appears to be a large root or possibly a cable running along the length of pipe between the 37 to 38m point in the pipe as highlighted by the straight line in the flat topography. This is seen in fig5 and fig6.

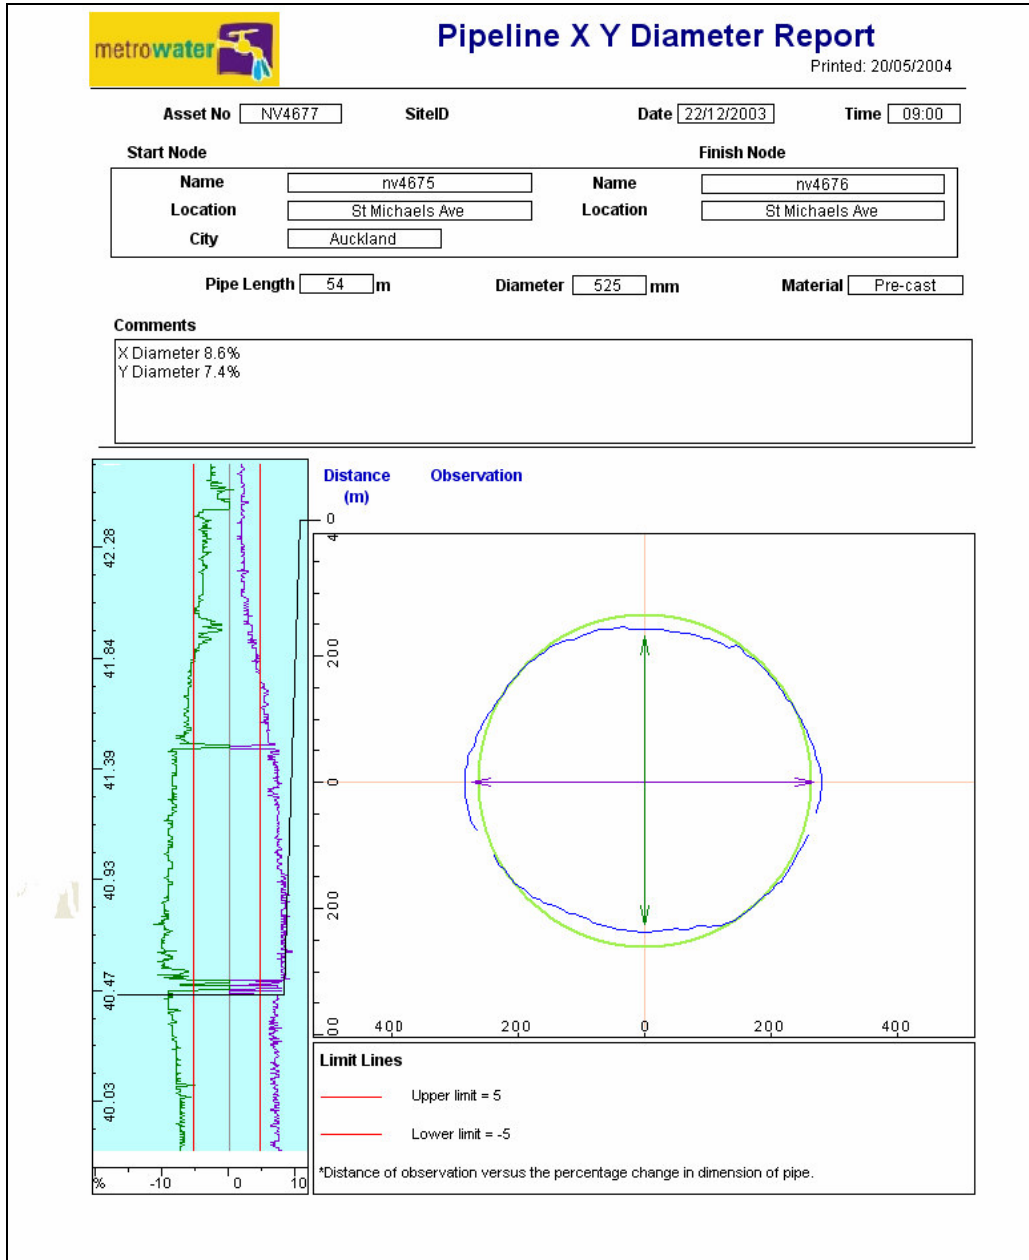
Fig7

The XY graph (fig7) displays the vertical diameter and the horizontal diameter in terms of a percentage change from the expected diameter of 525mm. The digital profile shown, highlighted as severe in the XY graph to the left, is 40m from NV4676. In this case the X diameter is 39mm (7.4%) in excess of the expected Y diameter whilst the Y diameter has been reduced by 45mm (8.6%).

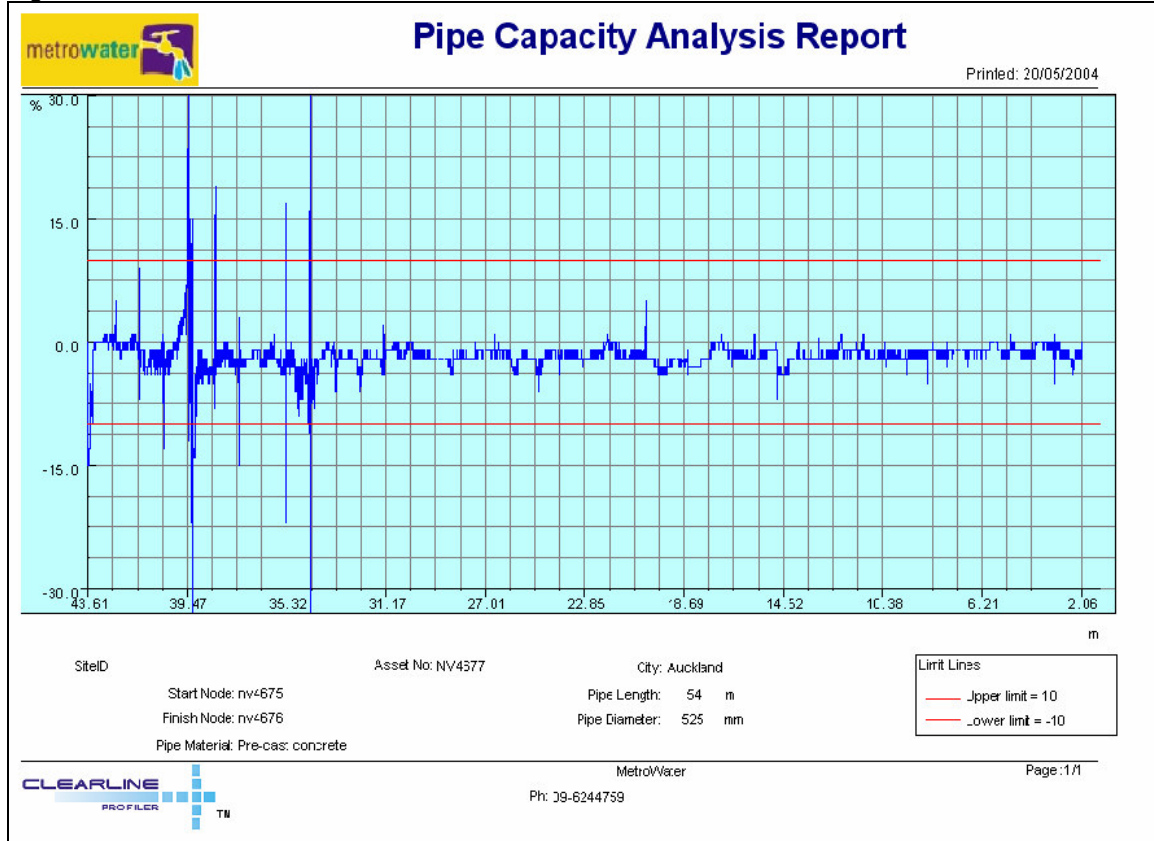
Fig8

The Capacity graph in fig8 highlights a loss or gain in cross-sectional area in percentage throughout the total length profiled. The baseline (0.0) indicates the expected cross-sectional area for an unaffected new 525mm pipe. Although seriously deformed between 33m and 42m as seen in the ovality, XY and flat graphs, there is no major loss in capacity (1.6% for the section of pipe profiled). Note: The calculation of 1.6% does not include the capacity loss due to the roots intrusion at 43m.
