CASE STUDY FOR SEALING OF FAILED JOINT AT SOUTH TOWN OUTFALLS, DARTMOUTH.

Location: South Town Pump Station, Dartmouth.
Date: April 2008
Client: Black & Veatch/ South West Water.
Contractor: Exjet Services.

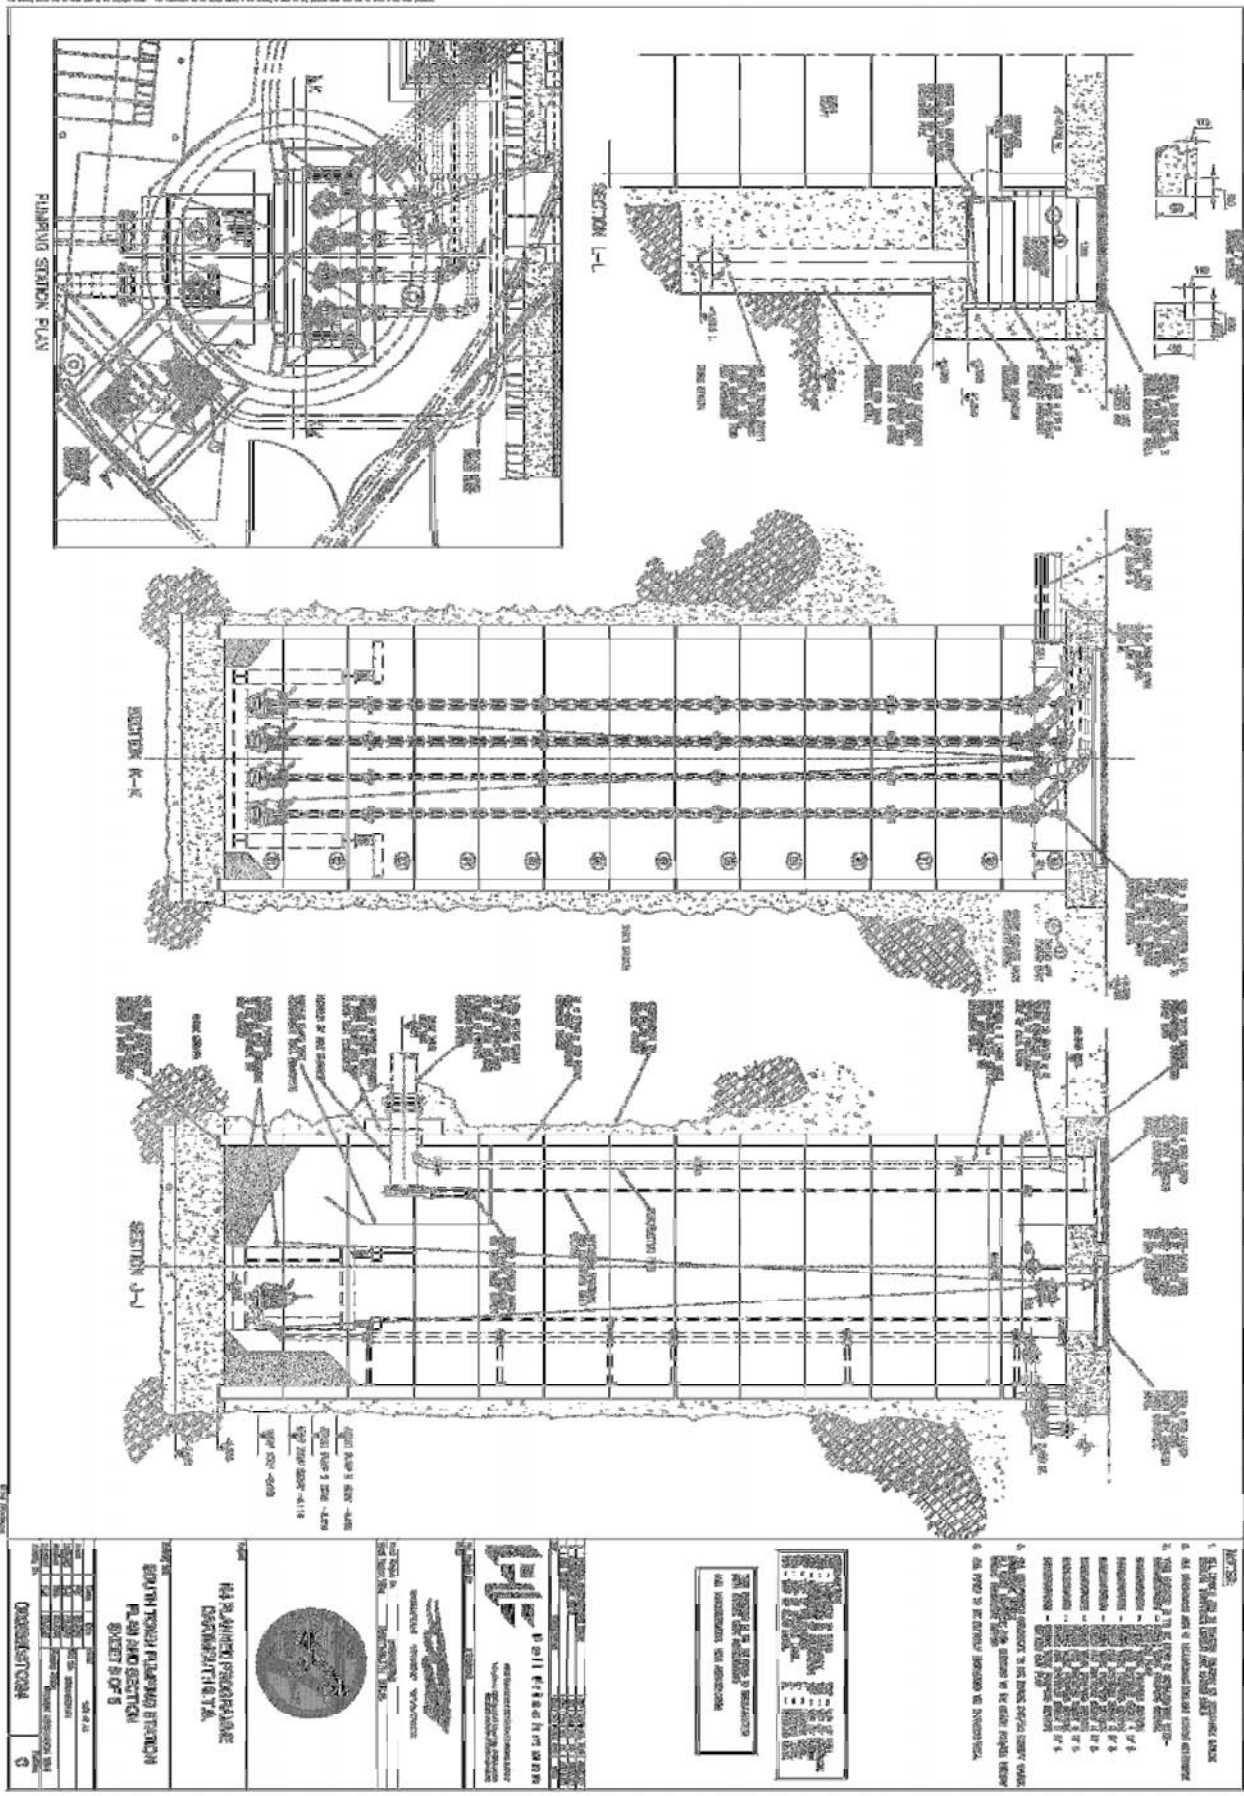
The survey clearly identified a failed joint at approximately 2.25M upstream of the pump station. This was subsequently identified as the joint between the stainless steel header from the pump station and the new PE Pipe.

- Any repair had to offer a long term water tight solution that would ultimately pass a pressure test of 2 Bar.
- The constructed pipe detail also included a deviation of approximately 15 degrees within the steel section consisting of a mitered and welded joint and a stepped flanged joint with an internal diameter variation of 40mm between the Steel and PE pipes.
